DUTCH
SAFETY BOARD

Preliminary report Crash involving Malaysia Airlines Boeing 777-200 flight MH17

Hrabove, Ukraine - 17 July 2014

The Hague, September 2014

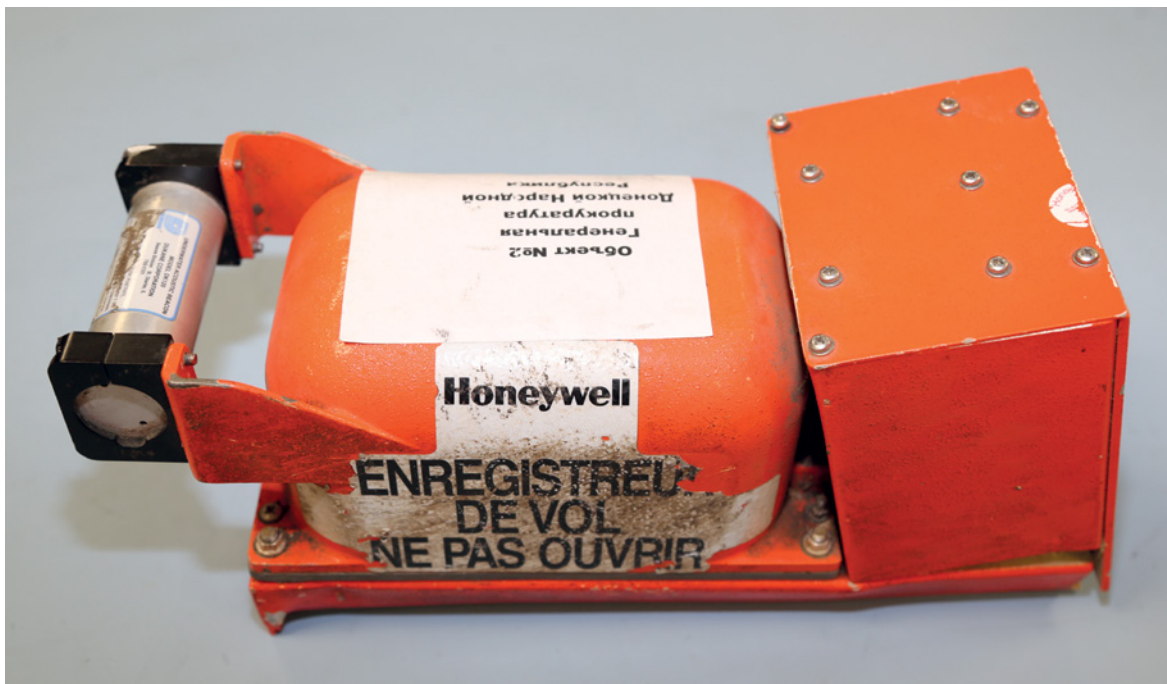
Figure 4: Cockpit voice recorder. (Source: AAIB)

The housing of the CVR (figure 4) had been damaged and, although the model and serial numbers were unreadable on the data plate, the serial number 1366 - matching the one provided by Malaysia Airlines - was found stamped on the underside of the chassis. The external damage found on the CVR is consistent with impact damage, the internal memory module was intact. The recording capacity of this recorder is 30 minutes.

The full 30 minutes were successfully downloaded and contained valid data from the flight.

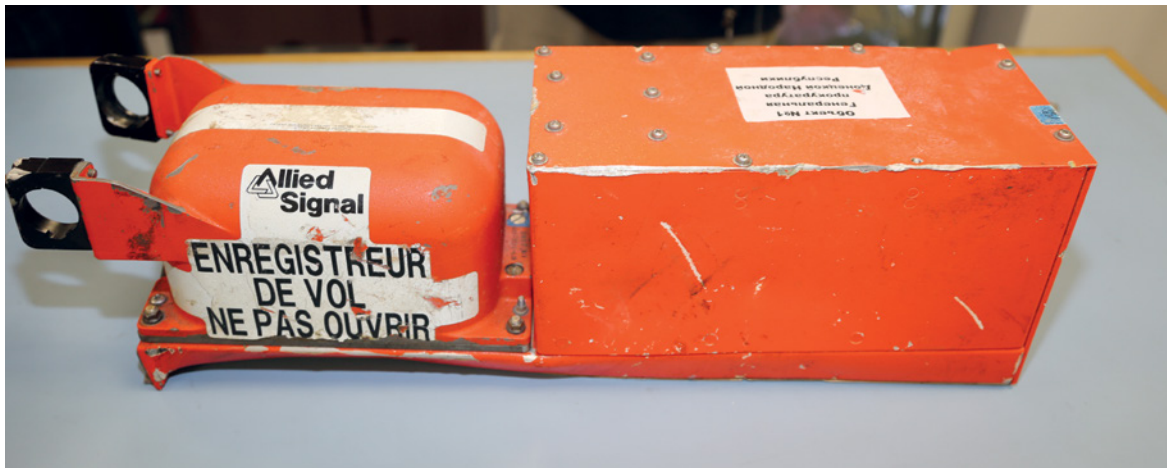
Figure 5: Flight data recorder. (Source: AAIB)

The label on the housing of the FDR (figure 5) showed that it was Allied Signal Model Number 980-4700-003 with Serial Number 2196. These details matched the details provided by Malaysia Airlines. The recorder was found damaged but the internal memory module was intact. The external damage found on the FDR was consistent with impact damage. The FDR, which can record 25 hours of operational data, was successfully downloaded and contained valid data from the occurrence flight.

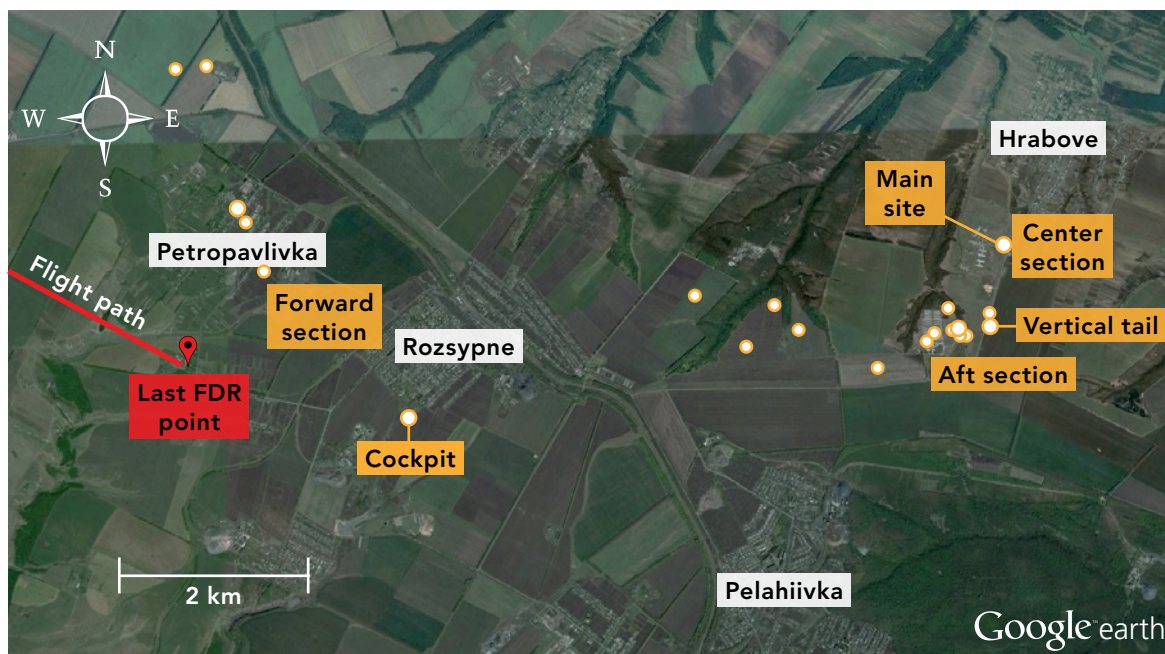
The aircraft wreckage, identified from the on-site photographs and satellite images, consisted of many large and small pieces distributed over an area of approximately 10 km by 5 km (figure 6). Fuselage pieces, cargo and baggage were scattered throughout the wreckage site. There were many additional unidentified pieces that are not shown in the figure. For easy reference the wreckage site has been divided into sections as shown in figure 6. These sections match with the aircraft sections shown in figure 7.

Figure 6: The last location of the aircraft in flight taken from the FDR. Wreckage distribution is grouped per section of the aircraft (Source: Google Earth, wreckage information Dutch Safety Board).

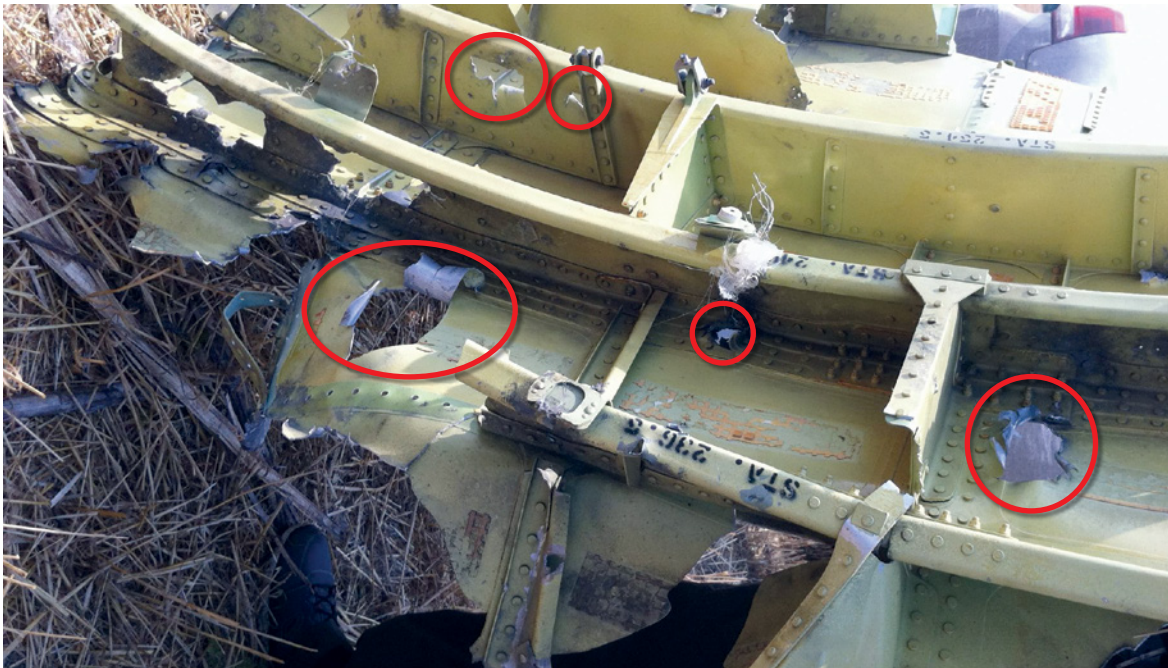
Around 1.7 km north of the position where the cockpit window structure was found, was a section of the cockpit roof also showing holes indicating penetration from outside (figure 9).

Figure 9: Part of the inside cockpit roof, indicating penetration with objects from outside. (Source: DCA)

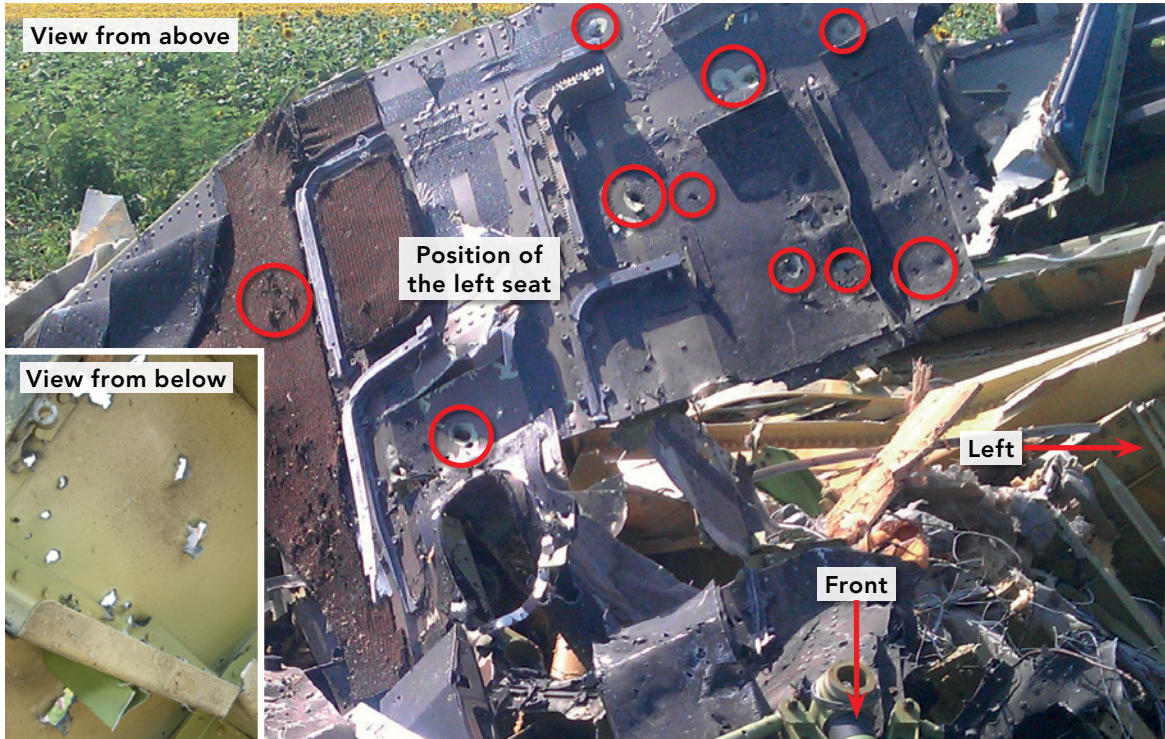
Puncture holes identified in images of the cockpit floor suggested that small objects entered from above the level of the cockpit floor (figure 10).

Figure 10: Cockpit floor with floor parts showing puncture holes (red circles) coming from above the floor.
(Source: NBAAI)
