DUTCH
SAFETY BOARD

Preliminary report Crash involving Malaysia Airlines Boeing 777-200 flight MH17

Hrabove, Ukraine - 17 July 2014

The Hague, September 2014

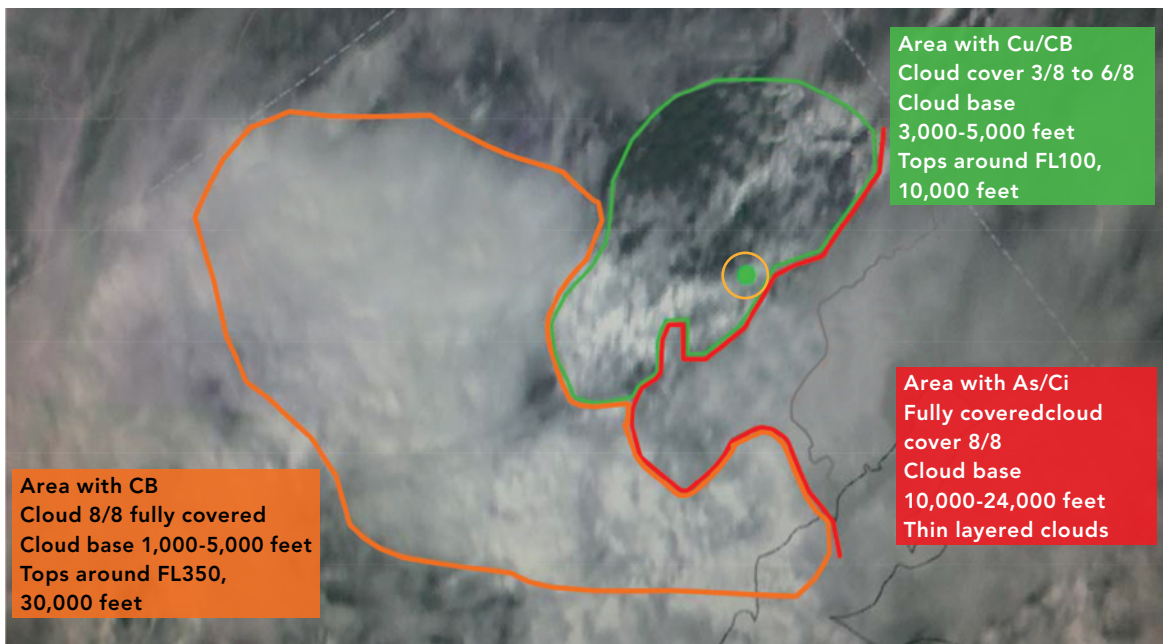
The orange area contains mainly Cumulonimbus clouds (rainclouds). The cloud coverage is mostly 8/8. The cloud base is around 3,000 to 5,000 feet, with the tops of the clouds reaching FL350 (35,000 feet).

The red area contains mainly Altostratus and Cirrus clouds, with cloud coverage being mostly 8/8, and the cloud base around 10,000 to 20,000 feet. The red area contains mostly thin layered clouds reaching 20,000 to 30,000 feet at places.

Figure 3: Cloud coverage for 17 July at 12.00 hrs.¹⁰ The circled green dot indicates the last position of aircraft. The orange area south-west of the accident location contains mostly Cumulonimbus clouds with possible thundershowers. (Source: KNMI)

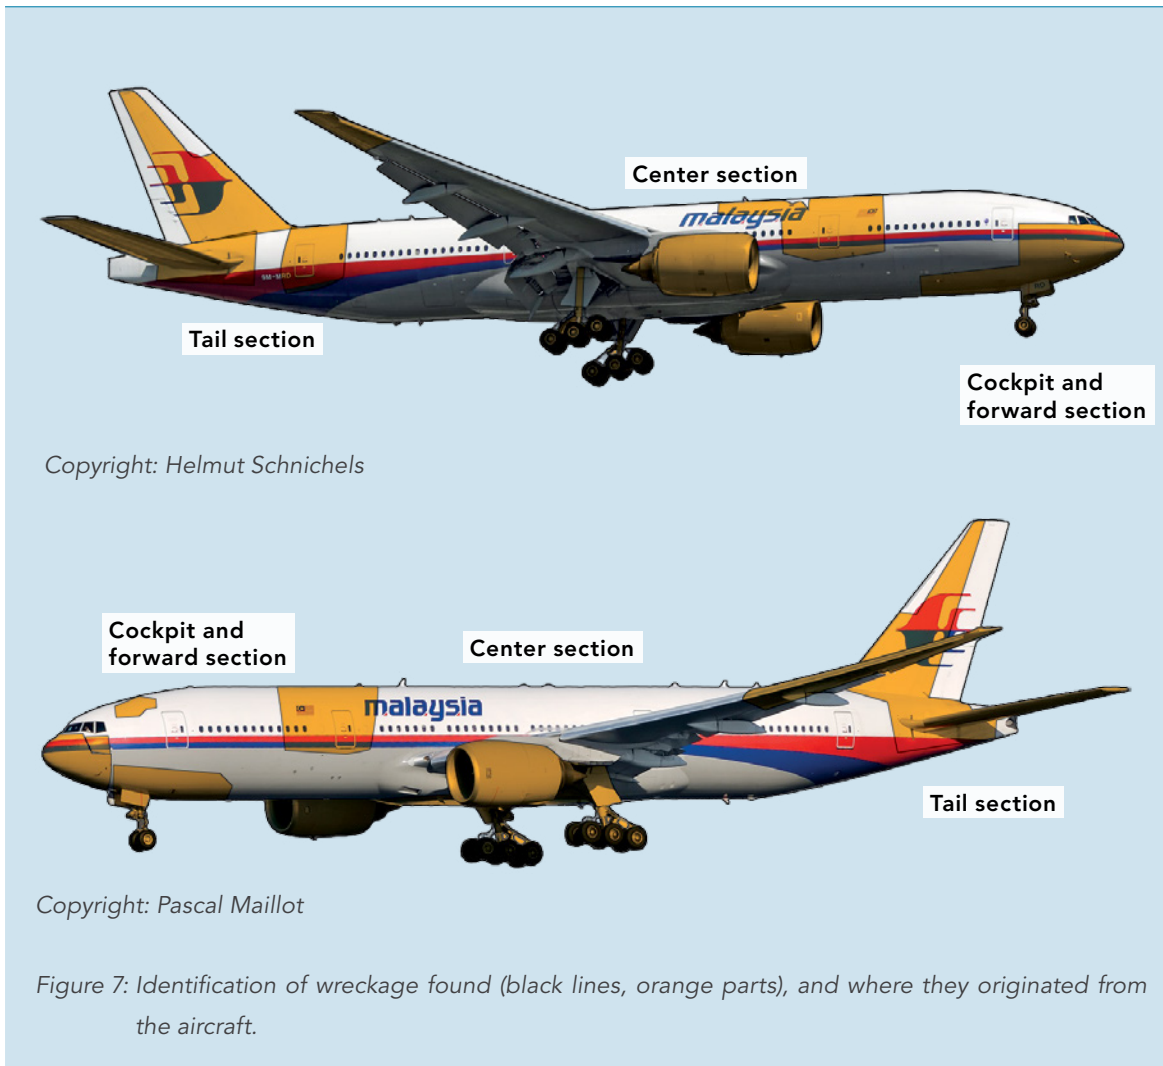
The aircraft wreckage, identified from the on-site photographs and satellite images, consisted of many large and small pieces distributed over an area of approximately 10 km by 5 km (figure 6). Fuselage pieces, cargo and baggage were scattered throughout the wreckage site. There were many additional unidentified pieces that are not shown in the figure. For easy reference the wreckage site has been divided into sections as shown in figure 6. These sections match with the aircraft sections shown in figure 7.

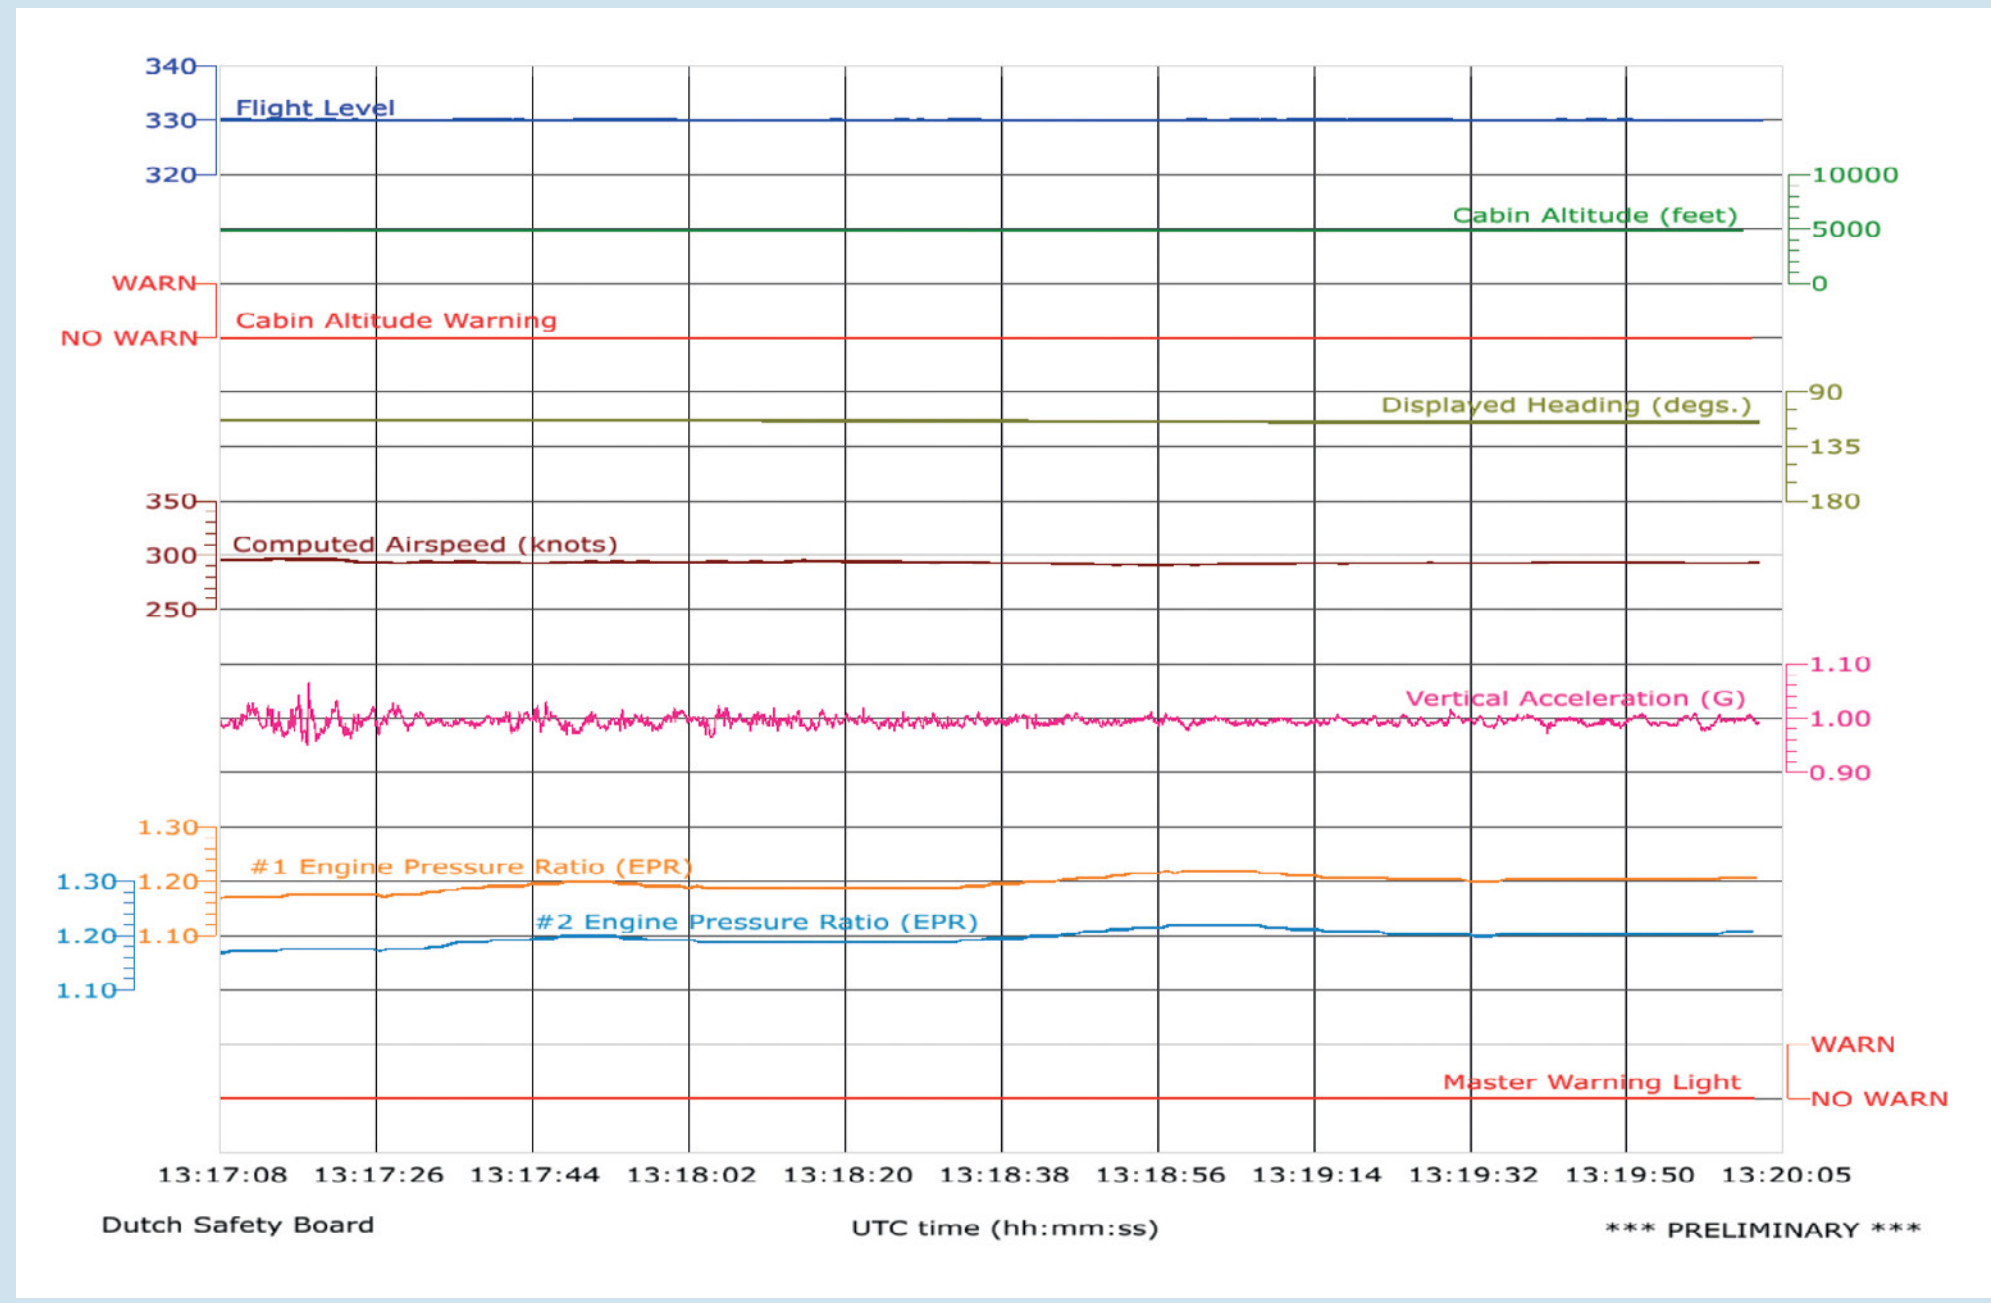
PRELIMINARY FDR DATA

The sampling rate of the various parameters displayed, vary from 8 times per second to once per 4 seconds. This explains why not all lines end at the same moment. Shown between brackets below, are the sampling rates of the various parameters.
